**Flood Control Project Maintenance
Levee Inspections**

Maintenance Issue Types Only, Levee Inspection Report By Mile - Fall 2018

Reclamation District No. 0787 Fair

Waterway	Bank	Unit Miles	Inspection Start/End	Inspector
Unit No. 01 Colusa Basin Drain	Left	4.45	10/09/2018 10/09/2018	Zach Jojola

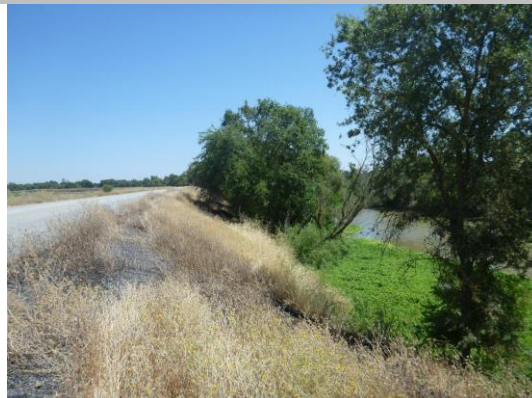
Photo 1 of 3 : LEVAL_FA_2018_182_1520.jpg

LM Start	0.73	Rating **	M	Issue No.	4	
LM End	0.86	Issue Type +	Ma	Location *		
Category	Supplemental			GPS Latitude/Longitude		
				Start	End	
Item	2017 Storm Damage			38.795769 °	38.796340 °	
				-121.736798 °	-121.738956 °	
DWR ID	DWR_RD0787_01_f _ 2017_4					
Comment Code						
Inspector Comment						
Levee Evaluation Comments						
Description:						
Site ID No:182						
Site Designation:RD 787-01						
Repair Type: Erosion						
Rating:Area of Concern						
Field Date:7/18/2017						
Notes:

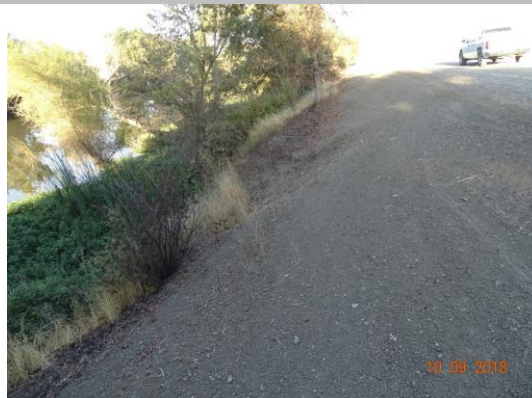
Photo 2 of 4 : FA_2018_RD0787_212_9_20181011_00012.jpg

LM Start	0.73	Rating **	A/W	Issue No.	9 (cont)	
LM End	0.73	Issue Type +	Ma	Location *	WS	
Category	Earthen Levee			GPS Latitude/Longitude		
				Start		End
Item	Erosion / Bank Caving			38.795814 °	38.795814 °	
				-121.736799 °	-121.736799 °	
DWR ID	DWR_RD0787_01_s_2017_9					
Comment Code						
E1 : Note and monitor erosion site.						
Inspector Comment						
Erosion on the waterside slope from 2017 storms. Recommend monitoring.

Additional view of erosion, facing upstream. Fall 2018.

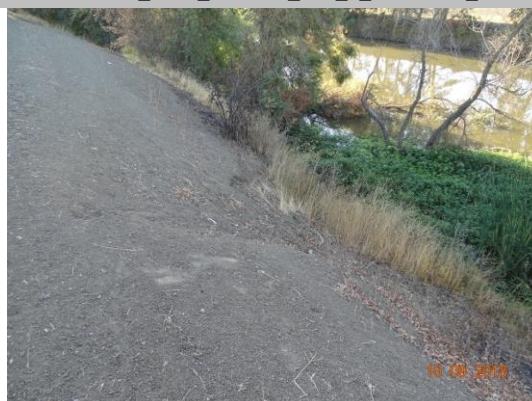
Photo 3 of 4 : FA_2018_RD0787_212_9_20181011_00014.jpg

View of erosion, facing downstream. Fall 2018.

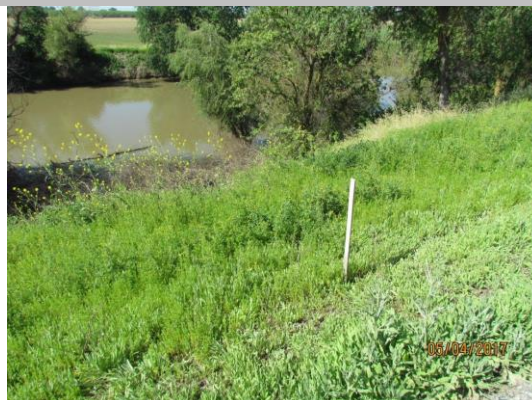
Photo 4 of 4 : FA_2018_RD0787_212_9_20180904_00004.jpg

View of what appears to be a slope stability issue on waterside slope.
Spring 2017.

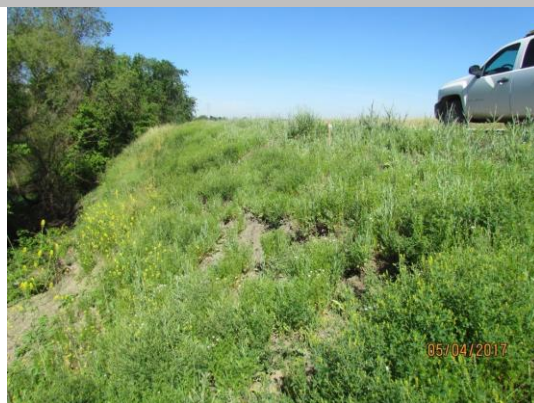
Photo 2 of 2 : FA_2018_RD0787_212_16_20180904_00007.jpg

LM Start	0.78	Rating **	A/W	Issue No.	16 (cont)	
LM End	0.78	Issue Type +	Ma	Location *	WS	
Category	Earthen Levee			GPS Latitude/Longitude		
				Start		End
Item	Erosion / Bank Caving			38.796042°	38.796042°	
				-121.737661°	-121.737661°	
DWR ID	DWR_RD0787_01_s_2017_16					
Comment Code						
E1 : Note and monitor erosion site.						
Inspector Comment						
Erosion on the waterside slope from 2017 storms. Recommend monitoring.

View of what appears to be sloughing on the waterside slope. Spring 2017.
